FORT TANJONG KATONG RAISING HISTORY PLANTING ROOTS PROJECT

Preliminary Site Report version 1.2

Report by Lim Chen Sian on behalf of the Archaeology Team

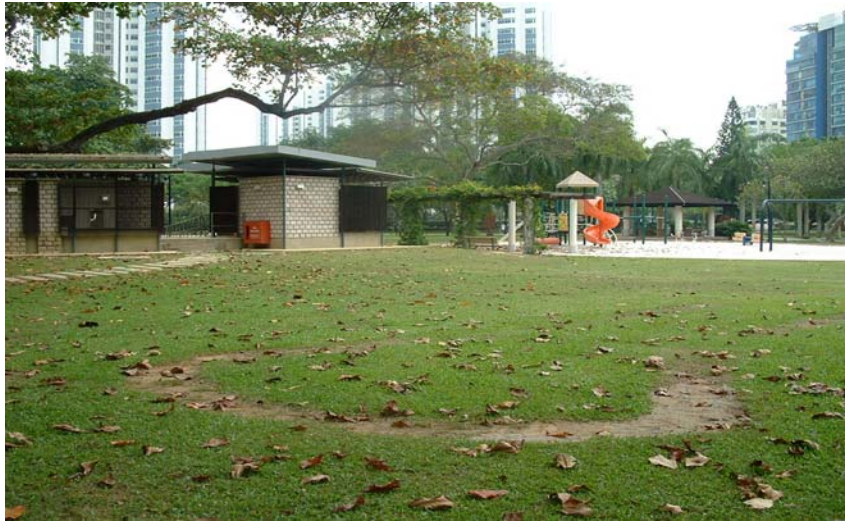
Figure 1. Remains of the fort are clearly visible prior to the project.

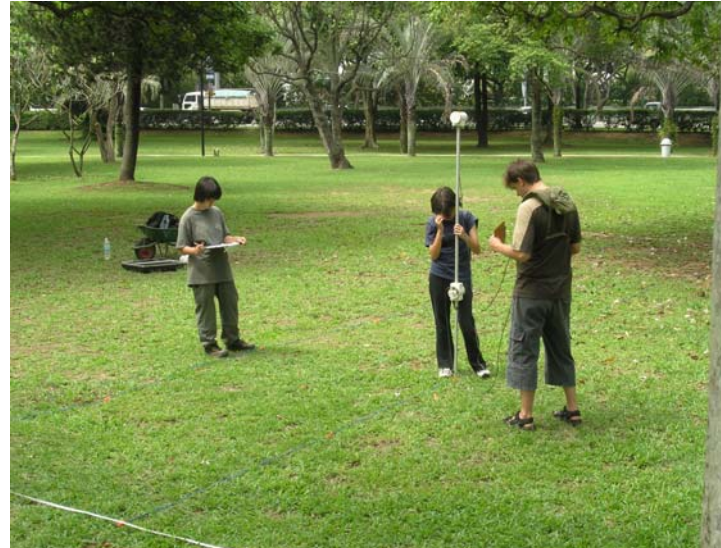
Figure 2. Remote sensing with wires. Figure 3. Magnetometer Survey.

2) Magnetometer Test, Survey and Mapping – Measurements of the site's subsurface magnetic anomalies have been conducted through magnetometer tests in hopes to identify structural outlines that are not visible and remained in situ and undisturbed from modern development at the park. The tests were conducted from the months of December 2004 through January 2005.

Three grids of 20m x 20m were laid out and readings were obtained at every 1m intervals. The test grids were randomly distributed across open areas of the site, where no park features, trees or other botanical intrusions are situated above ground. Two test grids were conducted on the western half of the park in the open area south of the identified drawbridge superstructure. A third test grid was set up north of the southeast bastion where the caponier passageway (and later educational pits FTK46-60) lies.

Due to the age of the magnetometer test machine, part of the data upon downloading for computer analysis were corrupted and results from the magnetometer test are still pending repairs of the magnetometer reader unit and hence inconclusive at this point of writing.

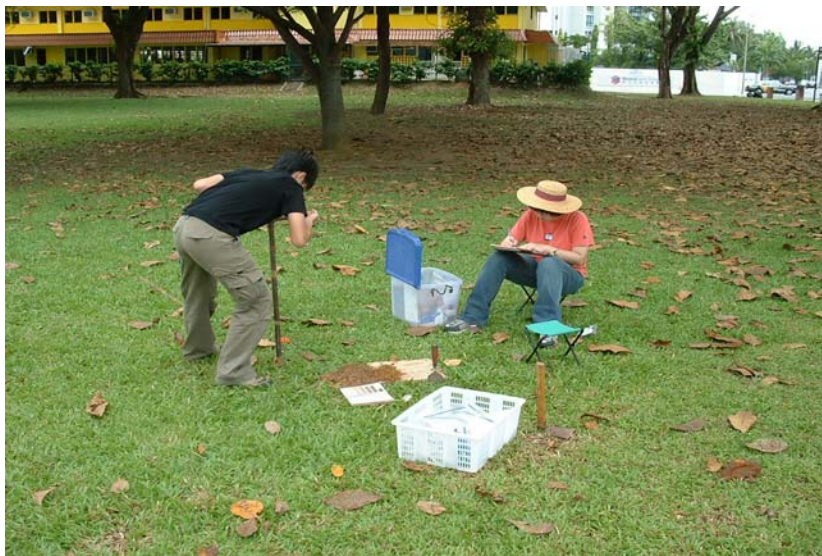
Figure 4. Subsurface coring tests.

1) Subsurface Coring Test – In the 2004 field season, two transects were laid along the locality of the suspected eastern inner moat wall of the fort, and coring was conducted along the transects at every 10m intervals. Supplementary coring tests were conducted during later phases of the project near test units with the intention of assessing the benefit to be obtained either by extending extant pits or opening up additional pits. At the point of writing a total of six transects are set up for the entire site:

All bore holes were immediately backfilled and remains unobtrusive. Coring tests revealed much secondary fill material comprising of clay and sand that were deposited after the abandonment of the fort. The stratigraphic layers of the site are generally uniform and consist of modern tuff and sod at the top (surface to 10cm below surface) followed by a thick layer of yellow/orange compact clay (10 – 90 cmbs), coarse to fine sand (90 – 200cmbs), and the water table at approximate 200cmbs.

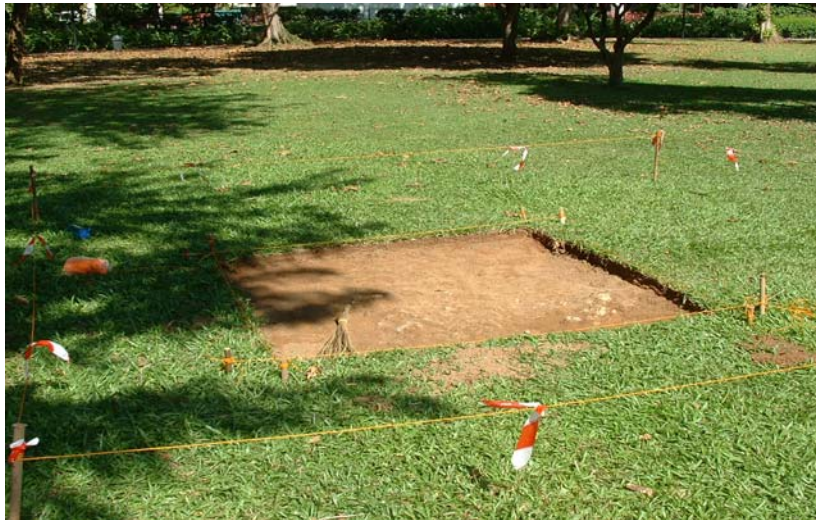
Figure 5. Test pit excavation (FTK 1 and 2).

1) Test Pit Excavations – Two 2x1m test trench (FTK 1 and 2) were excavated at the suspected northeast corner of the fort inner moat wall. To date, twenty-two 2x1m test trenches (FTK 5-22, 30, 33-36) were opened to expose the prominent southeast horseshoe shaped feature. The archaeologists believe this feature to be a bastion, a defensive feature of fortification architecture to protect the corners of a wall or moat, enabling the defenders to bring fire upon the flanks of attacking forces assaulting the walls.

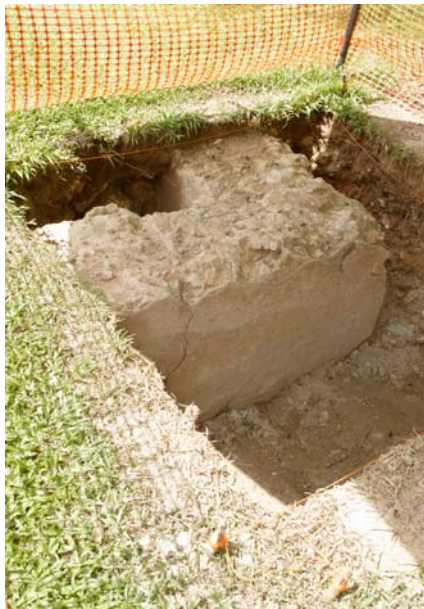
Figure 6. Corner wall revealed (FTK 1 and 2).

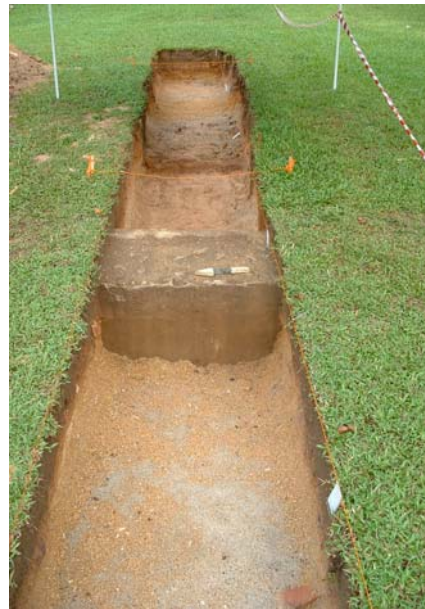
Figure 7. Moat trench (FTK 23, 24, 25, 28 and 29).

Five 2x1m test pits (FTK 23, 24, 25, 28 and 29) were excavated across the suspect east moat, which historical records indicate to be 100ft wide. The moat trench excavation is directed at recovering any artifacts which may have been discarded in the body of water during the occupation period of the fort as well as to provide a profile of the stratigraphy of sediment deposits.

The moat area trenches (FTK 23, 24, 25 & 28) produced significant amounts of coral and polished sand stone. Finely ground coral fill is found within the confines of the inner moat wall. Artifacts of note include a single horseshoe and glass shards. As indicated above, the coral samples are presently under going analysis at the Raffles Museum of Biodiversity Research.

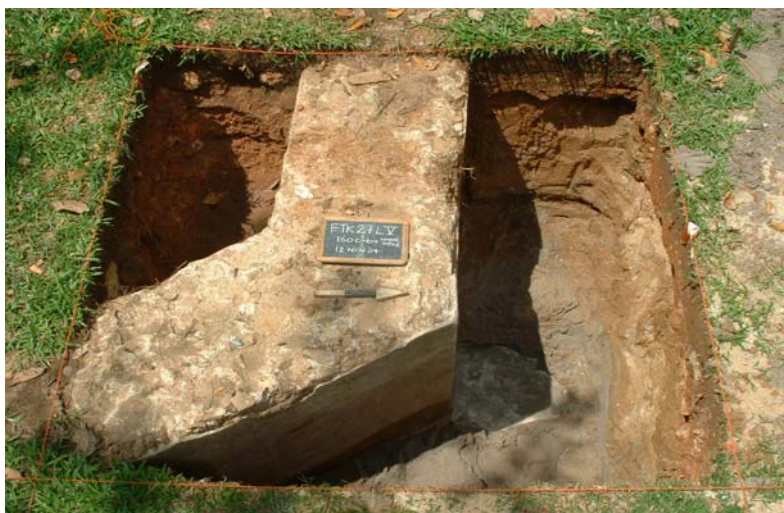
Figure 8. Northeast Corner Wall (FTK 26 and 27).

Additional test pits were opened to explore the other corners of the fort, chiefly in the suspected vicinity of the drawbridge (FTK 26, 27, 31, 32, 38 and 39). The water table at FTK 27 is higher at 160cmbs due to the lower elevation on the northern half of the site. The footing of the wall in FTK 27 is found to be around 210cmbs.

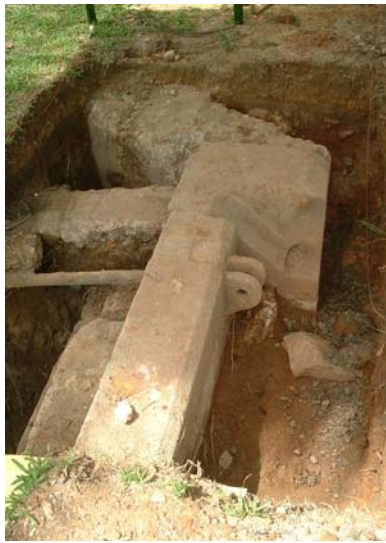
Figure 9. Drawbridge Superstructure (FTK 31, 32, 38 and 39).

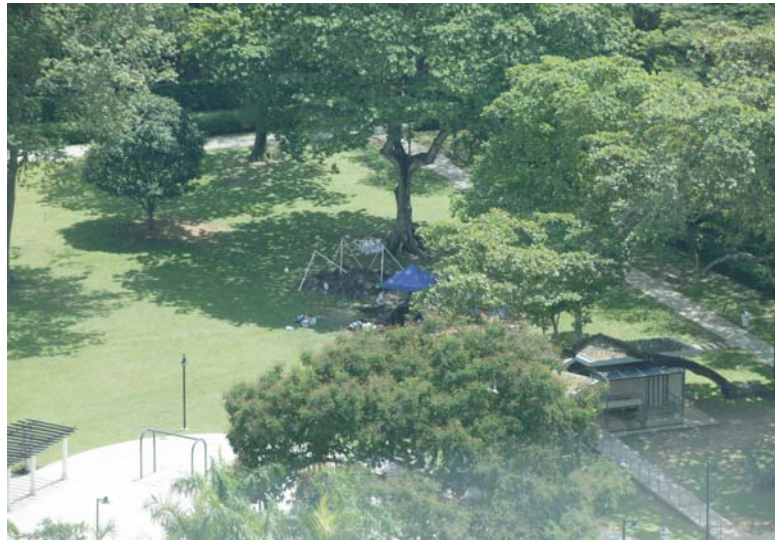
Figure 10. Aerial View of excavations at Katong Park. Tents are located over the Southeast Bastion (FTK 5-22)

The main area of excavation for 2004 season was primarily concentrated on the southeast bastion feature. Stratigraphic profile of this feature comprise of modern tuff and sod on at the top (surface to 10cmbs), compact layer of yellow/orange clay (approx.10 – 30cmbs), followed by a black layer of construction fill midden (refuse) material (30 – 110cmbs), and fine marine

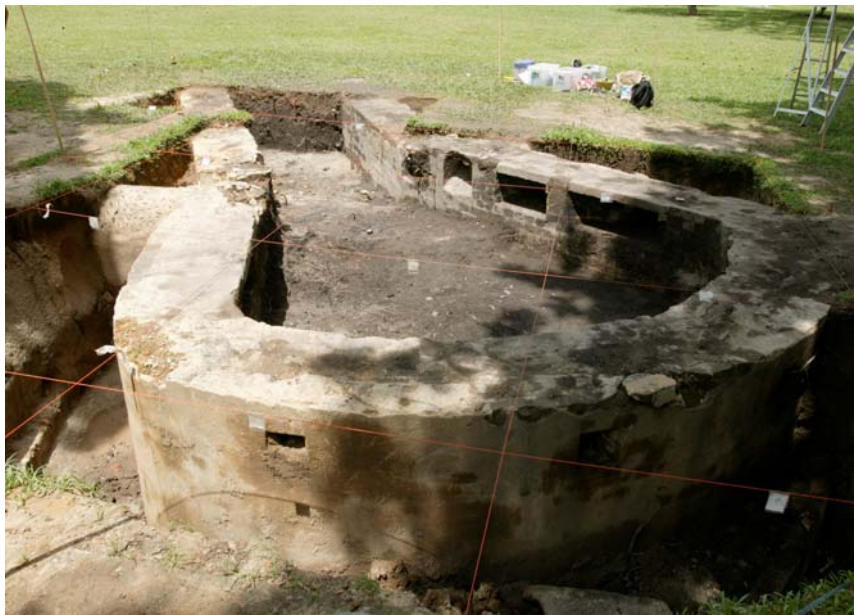
Figure 11. Southeast bastion (FTK 5-22).

sand (110 – 150cmbs). The construction fill material was the result of the land reclamation project of the East Coast in the late 1960s where the shoreline bordering the park was obliterated and leveled out.

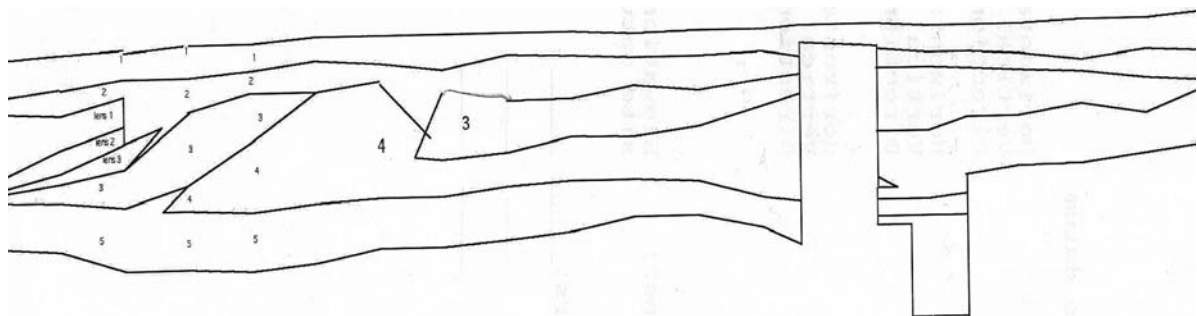
Figure 12. Stratigraphy profile; 1.top soil/sod 2.orange clay with coral 3. fine yellow sand 4. light grey sand 5.orange clay. Profile of moat trench (FTK 23, 24, 25, 28 and 29).

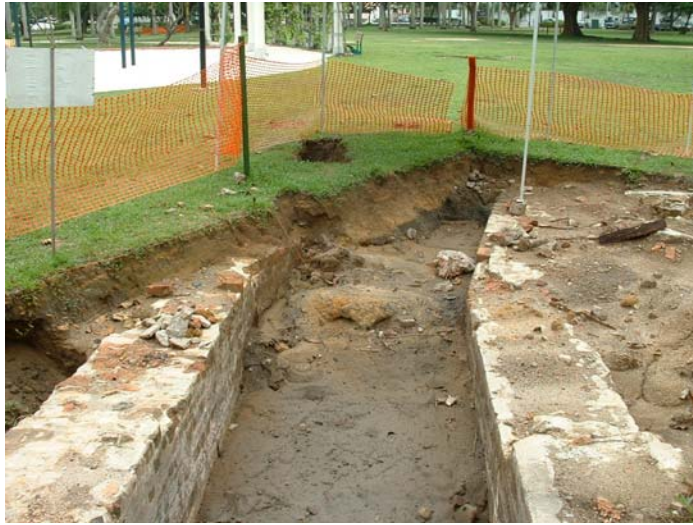
Figure 13. Southeast caponier passageway. (Education Pits FTK 45-60).

The 2005 field season saw a further 40 2x1m test units opened, sixteen (FTK 45-60) of which are dedicated as education pits for the influx of student volunteers. FTK 45-60 is situated over the caponier passageway leading into the southeast bastion.

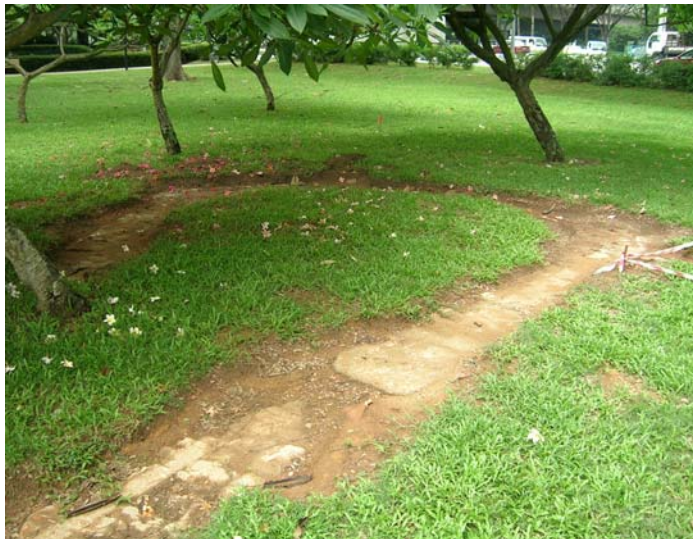
Figure 14. Southwest bastion. This feature remains unexcavated.

Another bastion was discovered during survey of the western half of the site on 5th February 2005. A particularly dry spell and record high temperature resulted in much of the grass to wither away in the park revealing a distinct discoloration in the ground where subsurface features are buried. The southwest bastion is found beneath a grove of trees and extending outwards is the caponier passageway measuring some 24m in length. Apart from the clearing of the top soil and sod, this bastion remains unexcavated. Likewise, it is uncertain if this bastion was featured as part of the 1885 plan to upgrade the facility.

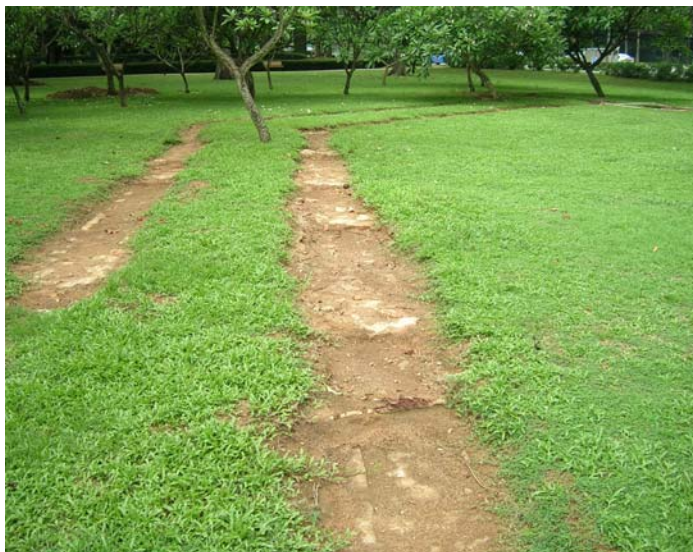
Figure 15. Caponier passageway leading into the southwest bastion. Caponier measures some 24m in length.

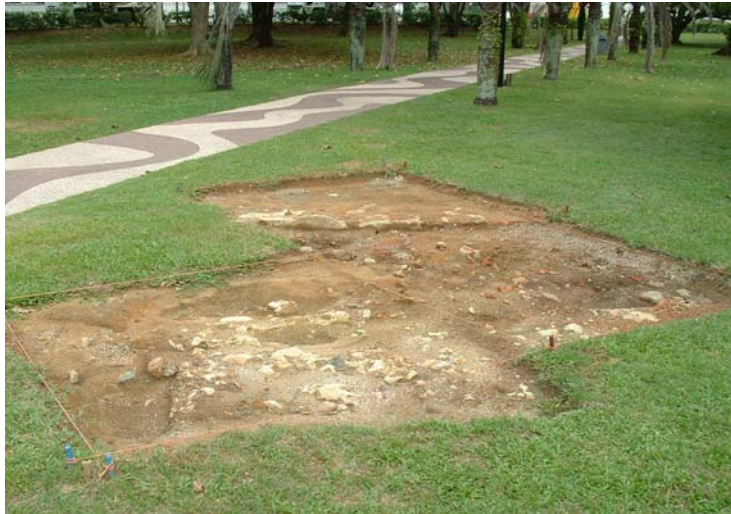
Figure 16. Rubble field at the end of the southwest caponier passageway (FTK 70-75).

Several rubble fields were investigated; FTK 61 and 62 adjacent to the unexcavated southwest bastion, and FTK 70-75 at the end of the caponier passageway leading to the southwest bastion. Dense concentration of rubble resulted in these pits being abandoned.

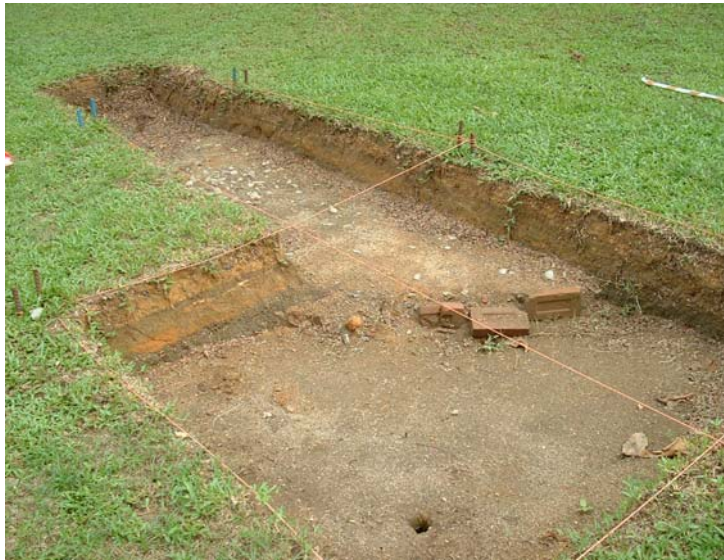
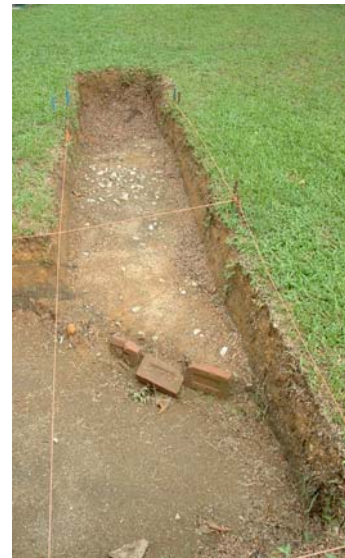
Figures 17 and 18. 1930s Park footpath uncovered (FTK 63, 64, 69 and 78)..

The majority of the remaining test pits were sunk to explore for remains of the fort's interior; FTK 42 north of the fitness center; FTK 63, 64, 69 and 78 west of the playground; FTK 66, 67, 76 and 77 west of improvised soccer pitch. These test pits proved to be sterile of 19th century cultural remains from the fort. Approximate depth of excavation is 40cmbs where either rubble was uncovered and the unit abandoned, or a coring test was conducted within the unit to ascertain sterility.

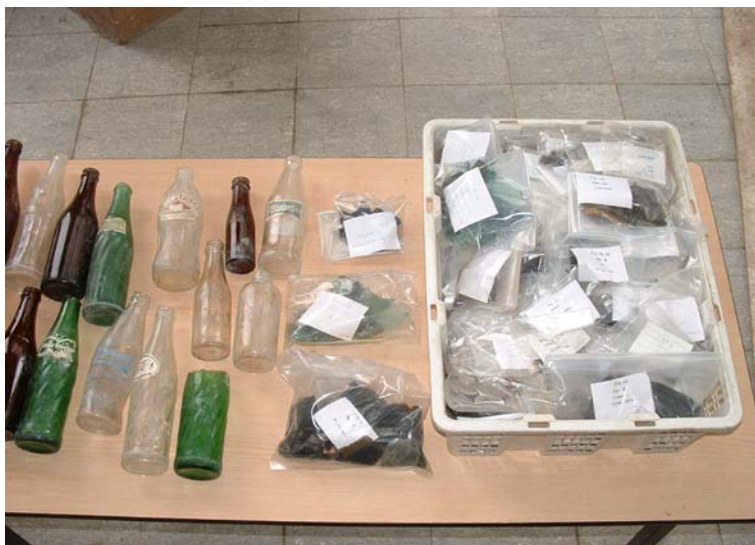
Figure 22. Bottles and glass shards recovered from the site.

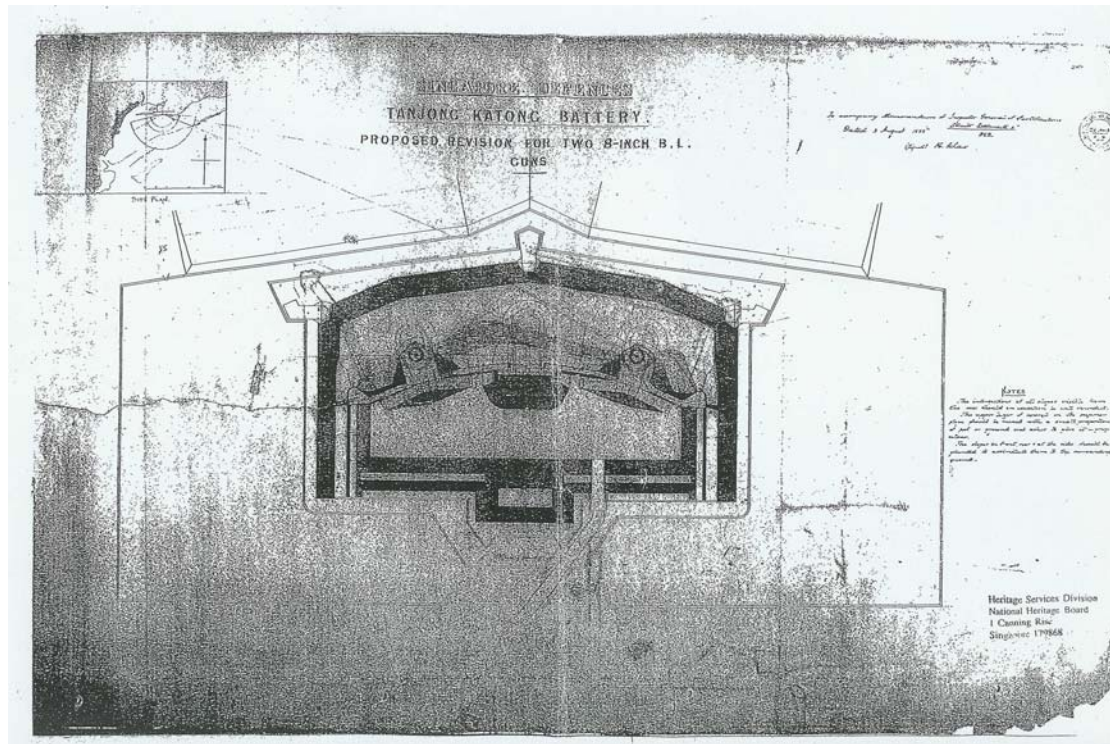
Figure 23. 1885 plan for the proposed revision to the existing battery (*Historical background of Katong Fort*, Historical Sites Unit, National Heritage Board Report 2002).

In 1885 work began on upgrading the existing gun batteries in Singapore, and the three gun battery at Tanjong Katong was replaced with a pair of more powerful and longer range breech loading 8 inch guns. Modifications and additional fortifications were made to strengthen the position and the Tanjong Katong battery was elevated to the status of a Fort.¹⁰

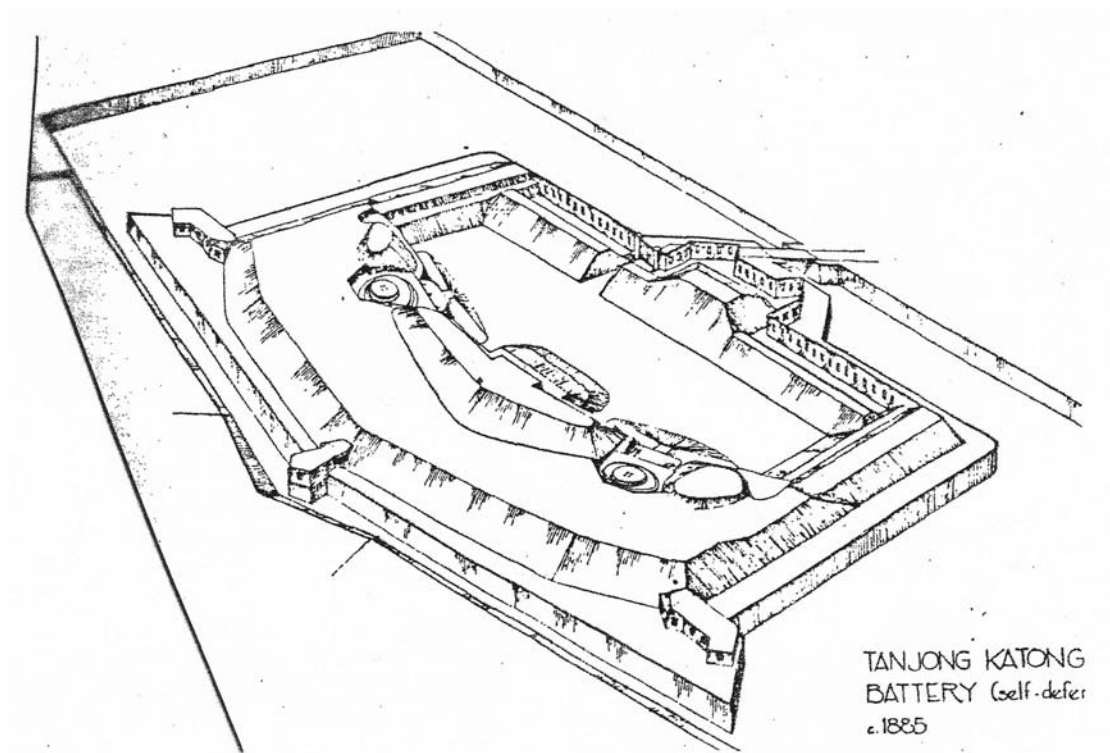
Figure 24. Sketch of Tanjong Katong battery c.1885 (courtesy of Alan Harfield).

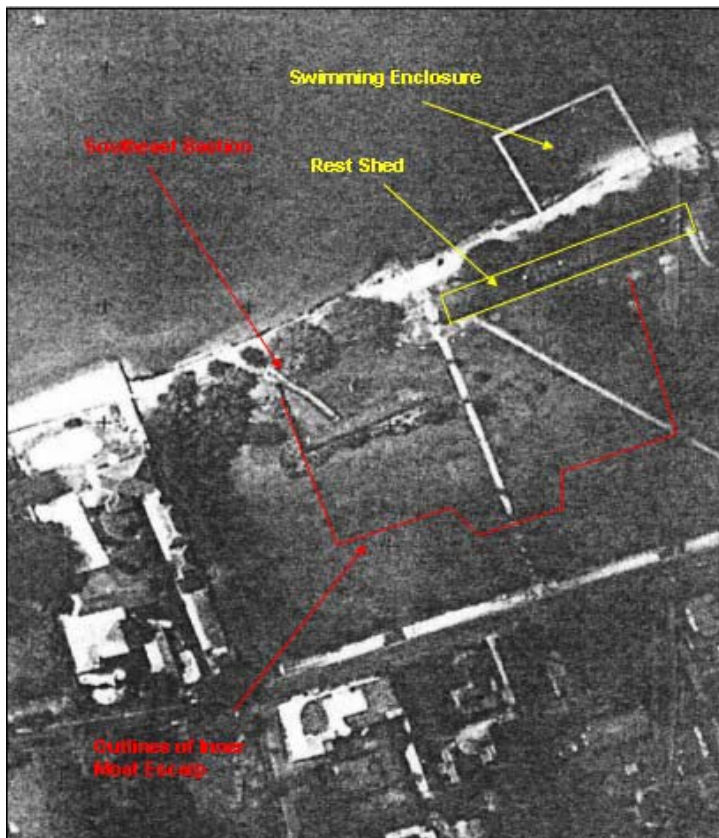
Figure 26. Magnification of air photo. The swimming enclosure, rest shed (former Japanese machine testing bays), southeast bastion, perimeter of the moat escarp are visible.

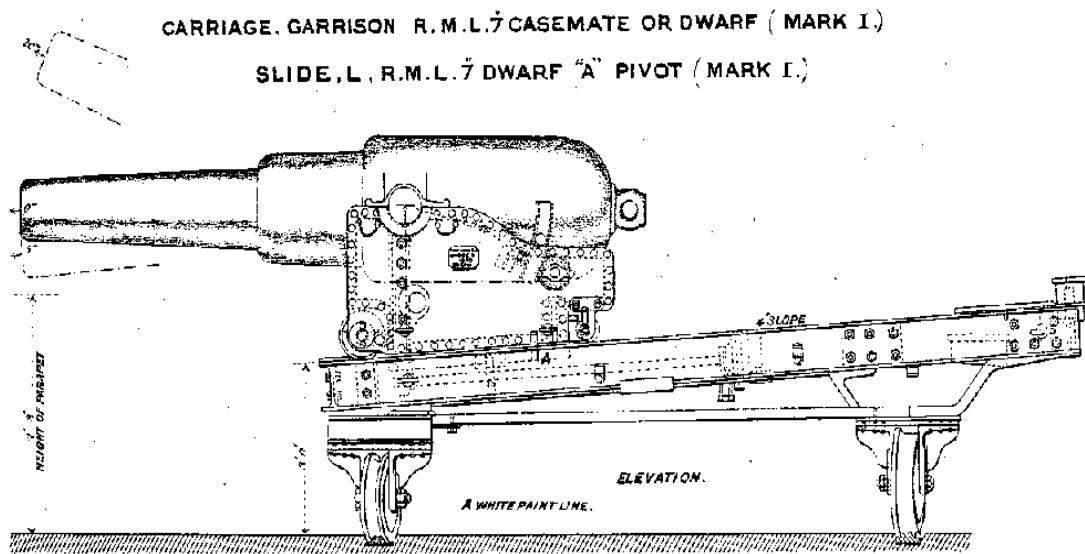
Figure 29. Line drawing of 7 inch Rifled muzzle loader (RML) of 7 tons (courtesy of David Moore).

Fort Tanjong Katong had initially started off as a three gun battery consisting of 7" Rifled Muzzle Loader (RML) of 7 tons, possibly manufactured by Armstrong from 1879-1885 and mounted on dwarf carriages. The 7-ton gun was the smallest of the guns classified as Heavy RML. It was the smallest gun mounted for coast defense and could have been on either an A or C pivot mounting. These mountings differed in that the C pivot had a central pivot and the racers were circular. The 7" RML of 7 tons were only to be found at the Tanjong Katong battery. The rest of the forts at Pasir Panjang (today Labrador), Palmer, Siloso, and Blakan Mati East were all of the 7" RML 6.5 tons design.¹⁷ Examples of this latter type, including a complete replica on its chassis can be seen at the Fort Siloso Gun Museum on Sentosa Island.

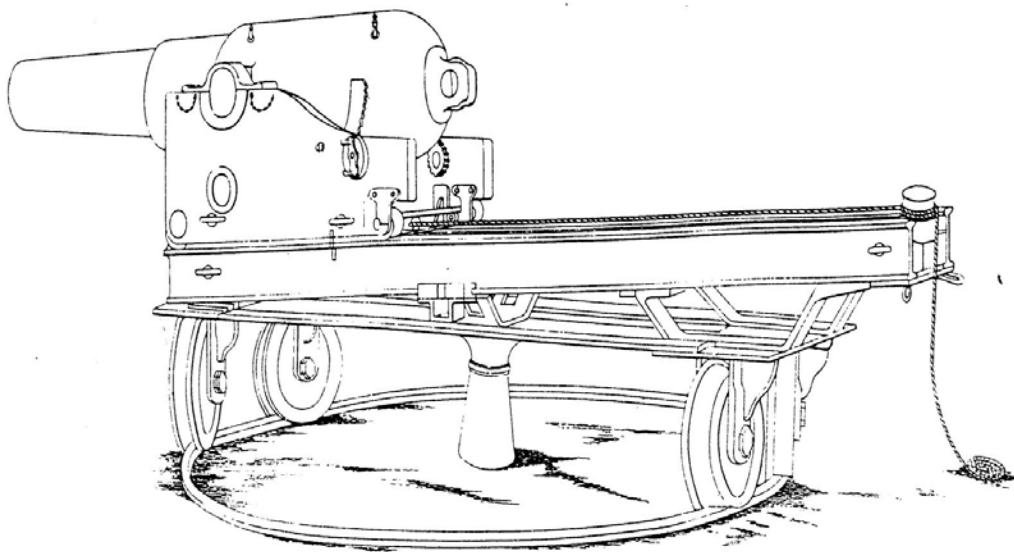
Figure 30. Drawing of 7 inch RML on C pivot mount (courtesy of David Moore).

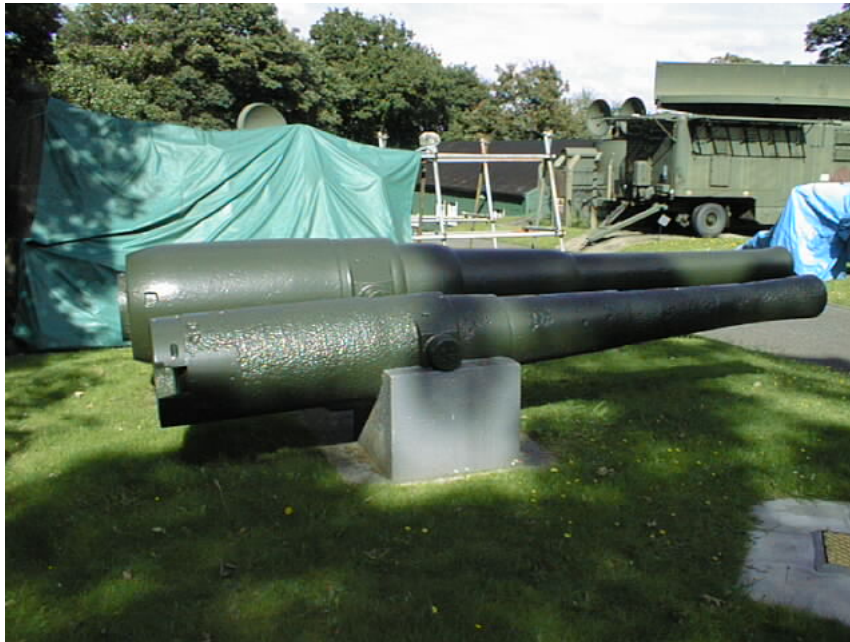
Figure 31. Rear – The Singapore 8 inch Breech Loading (BL) gun now on display at Royal Artillery Museum United Kingdom. It was removed to the UK in 1967/8 and originated either from Fort Tanjong Katong or Fort Serapong on Blakan Mati (David Moore).

One of the surviving 8" BL gun barrel from Singapore remain on display at the Fort Siloso Gun Museum, whilst another piece can be found at the Royal Artillery Museum's grounds at Rotunda, United Kingdom (No.3/242 Royal Artillery Catalog with the serial no.7278 incised on left trunnion along with 1890 date.) *The Gunner*, the magazine of the Royal Artillery, recorded the arrival of the gun in 1968. According to various correspondences, it was one of three decommissioned from Serapong and buried in the hill adjacent to the fort in 1913. Sometime between 1956-58 two pieces were disinterred and mounted as a memorial on the main parade square of Blakan Mati and that one was taken back to the UK in 1967-8. The location of the third gun (if it exists) remains unknown.²⁰
